NPIC/R-172/65

PHOTOGRAPHIC INTERPRETATION REPORT

HU-LU TAO HARBOR AND PORT COMPLEX CHINA

HU-LU TAO HARBOR AND PORT COMPLEX, CHINA

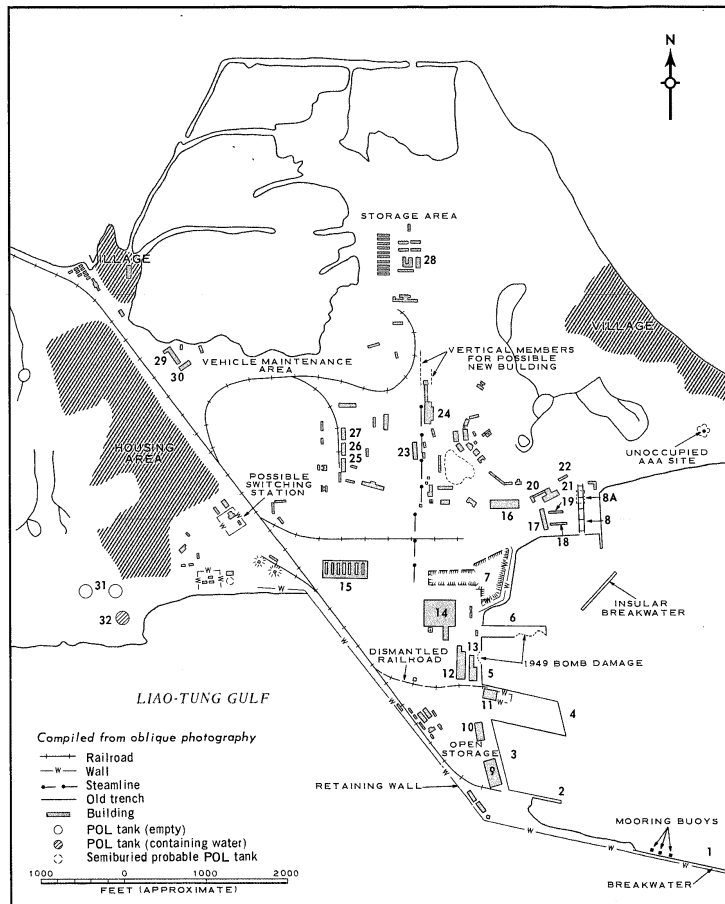
FIGURE 2. HU-LU TAO HARBOR AND PORT COMPLEX.

following changes in the harbor and port area: construction has been started on a graving dock, a small section of land was reclaimed and a probable steam plant and storage/support buildings were constructed on this land, the northern mole (Item 4, Figure 2) has been eroded away in some sections. The bomb damage of 1949 has not yet been repaired in some areas.

[redacted] was the placement of some vertical wall members of a possible new building at the probable steamplant. Work on the graving dock has continued with minor amounts of material removed on the north wall of the basin. Some vehicular movement is discernible indicating activity; however, buildings that were under construction on both missions show no changes. The northern mole has not been repaired, and no steam or fuel is visible at the probable steam plant. The POL tanks appear to be in a state of disrepair; however,

one does appear to be filled with water.
